# PROJECT: METHIL SEAWALL REPAIRS

VALUE: £390,000  
ROLE: MAIN CONTRACTOR  
START DATE: OCTOBER 2013  
COMPLETION: MAY 2014

CLIENT: SCOTTISH POWER GENERATION  
DALDOWIE FUEL FARM  
UDDINGSTON  
GLASGOW

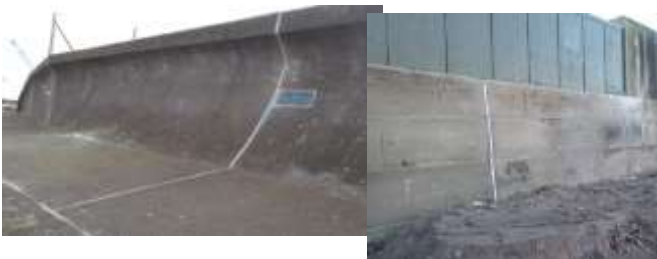
## EXPANSION JOINTS

Approximately 450m of split and missing expansion joints were repaired using Sikaflex Pro3, an elastic joint sealant with high mechanical resistance. The majority of joints were located throughout the vertical wall face and on the spillway floor.

The existing joint was first separated and removed to sound material before power washing and removing marine growth / vegetation. After the joint was completely cleaned, Aerofill Foam was placed inside the joint and a primer applied to the foam and surrounding concrete face. The expansion material, Sikaflex Pro3, was then injected into the joint by injection cartridge and screeded for aesthetical appearance.

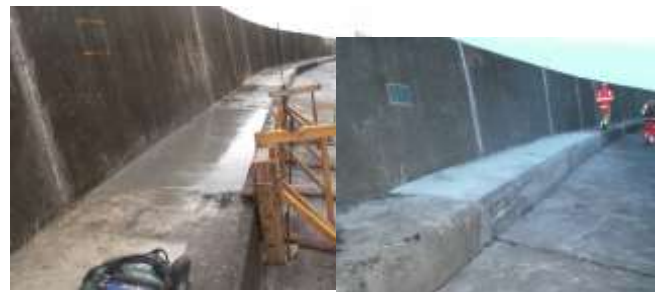
## SPALLING / SCOUR REPAIRS

Due to environmental forces, the seawall was prone to spalling and scours damage. It was in Southbay Civil Engineering scope to carry out the repairs necessary to these areas. Around 350m<sup>2</sup> of spalling / scour areas were repaired using Sika Armorcrete and Parex Marine Mortar for small repairs and Concrete C28/35 for larger repairs.

All areas damaged were cut to a minimum of 50mm depth and to sound material (using stihl saw and breaker). Using a power washer, the area was cleaned of marine growth. Timber formwork was then installed as per Temporary Works Design to suit the area of repair. The materials, Sika Armorcrete and marine mortar were then mixed by grout paddle mixer and poured to the area of spalling / scour.

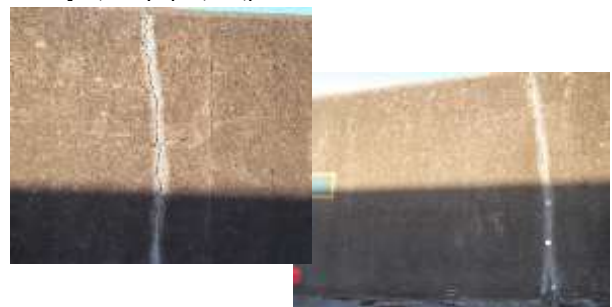
## RESIN INJECTION

Resin Injection was a method to accommodate cracks on the seawall (0.1mm-10mm). 327m of horizontal, vertical and diagonal cracks were repaired through this method. The material used was Parex Epoxy Injection Grout.

All cracks were cleaned of damaged mortar thoroughly by a wire brush and blown to make the surface area essentially dry. As per manufacturer's guidelines, the injection nozzles were located at 300mm centres of the crack. The grout was then mixed and inserted to the nozzles by means of a mechanical pump from the lowest point moving upwards. After 6-8 hours the resin was cured and nozzles were disposed of according
