PROJECT: NORTH BREAKWATER WALL RECONSTRUCTION, PETERHEAD.

VALUE: £530,000
ROLE: MAIN CONTRACTOR
START DATE: AUGUST 2016
COMPLETION: DECEMBER 2016

CLIENT: PETERHEAD PORT AUTHORITY
HARBOUR OFFICE
WEST PIER, PETERHEAD
AB42 1DW

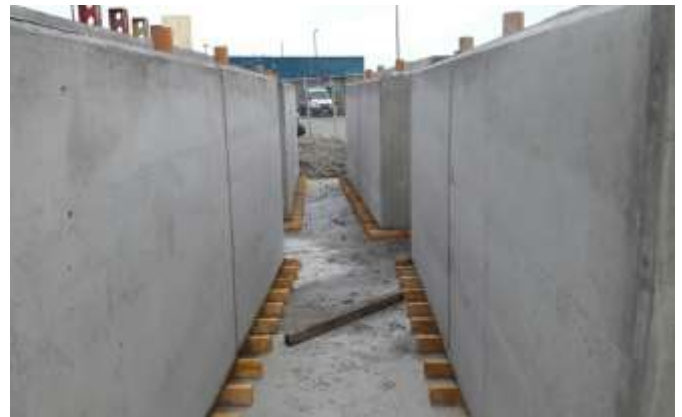
Precast Concrete blocks constructed on site

The project comprised of the repair of 30m of the existing North breakwater between low tide level and deck level. The works involved the dismantling and removal of the remaining damaged blockwork & concrete followed by the reconstruction using 26no 30 tonne precast concrete blocks which were also constructed on site.

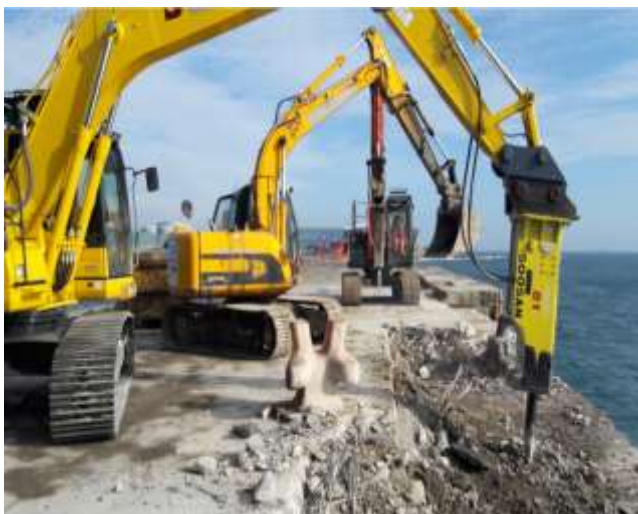
Breakout of the existing damaged section
